Double Reflow-Induced Brittle Interfacial Failures in Pb-free Ball Grid Array Solder Joints

ABSTRACT

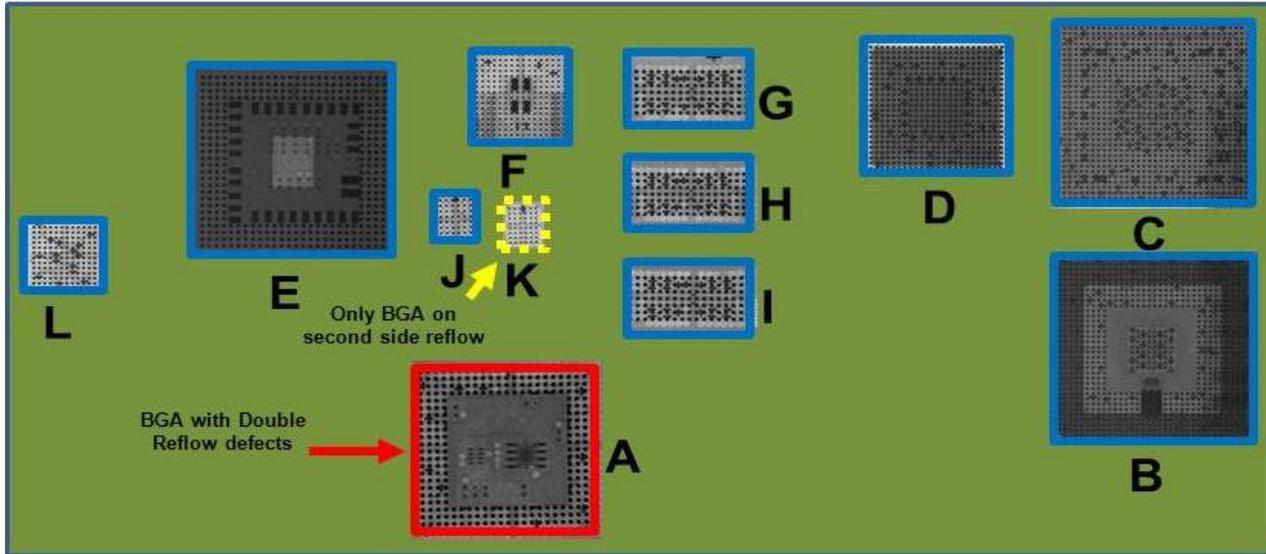
Figure 1 shows the layout of the printed circuit board assembly (PCBA) that contained the soldering defects. Table 1 provides detailed component descriptions for all the area array devices assembled onto the PCBA. All the BGA components with the exception of Component K were subjected to two reflow cycles. Due to the properties of the printed circuit board

(PCB), soldering was done using two vapor phase reflow cycles, instead of the more typical hot air convection reflow cycles. Following the second reflow, the assembly exhibited parametric failures at test. The parametric failures were traced to the plastic ball grid array component (PBGA) labeled Component A and designated by the red box in Figure 1. Component A, which is a perimeter array BGA, 31 mm², 304 I/O solder balls of 1.27 mm pitch and 0.76 mm diameter, exhibited intermittent solder joint electrical opens. There were no indications of solder joint electrical opens on any of the other components on the PCBA.

Figure 1: PCBA BGA Component Descriptions, Locations and Reflow Process.

The obvious path for elimination of the failures in this design was to subject the BGA-side of the PCBA to only a single reflow pass. This corrective action was implemented successfully. The soldering of the heavy daughter card modules on the non-BGA side of the board was achieved by modifying other aspects of the assembly process.

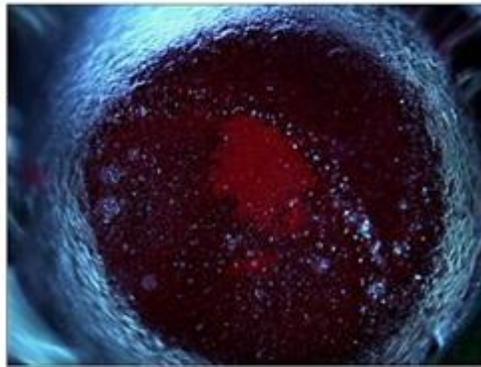
Figure 2: Optical photomicrograph of a failed solder ball surface after dye and pry (DnP) testing. This surface has fractured between the solder ball and BGA package pad (at the component side). The red color on the surface is from the dye intrusion that occurs prior to the mechanical prying.

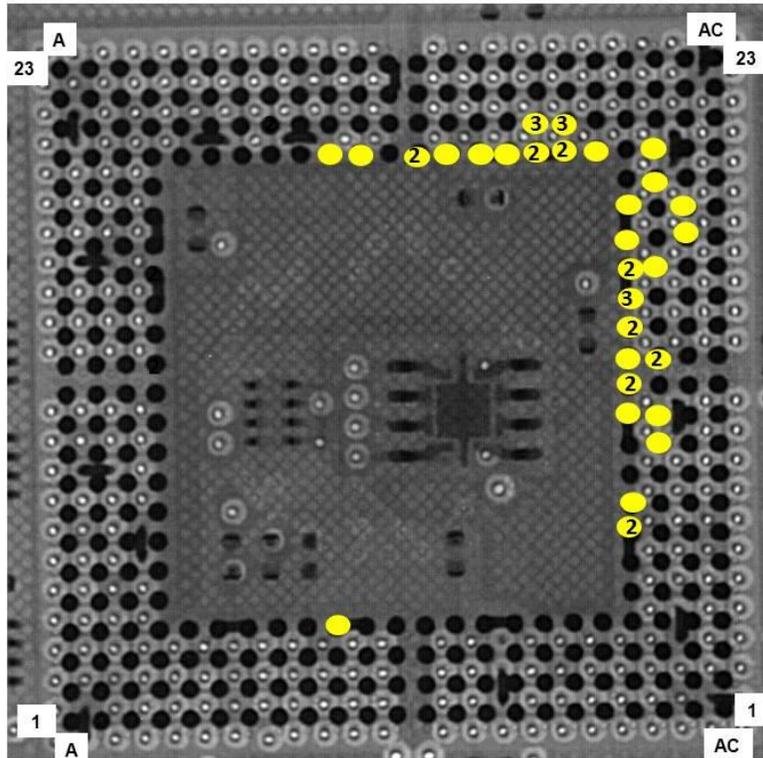
Figure 3 shows the a composite map of failure locations taken from three different Component A samples overlaid on a low magnification transmission X-ray micrograph of the package ball pattern. The pattern of indicted sites is asymmetric within the package array and is concentrated in proximity to the inner row of perimeter ball array. This inner row failure signature is atypical for many of the intermittent failure modes discussed in the previous section. Those types of failures tend to manifest in the outer rows at the corner and near-corner locations that are known to be the highest stress-strain locations in BGA packages. However, exceptions to this trend can be found in PBGA packages that exhibit certain specific warpage signatures. It is common for warpage stresses to be high at the corner sites, but they also can be high in the die shadow region due to the high CTE mismatch between the package laminate and the silicon die. Asymmetric failure patterns (Figure

3) are not common but when they occur, they are believed to result from mechanically or thermally unbalanced structures in either the PCB or the package that affect CTE and thermal transfer.

Figure 3: Failure location map from dye and pry test data overlaid on a transmission X-ray image of BGA Component A. This map is a composite of failures for Component A taken from three different PCBAs.

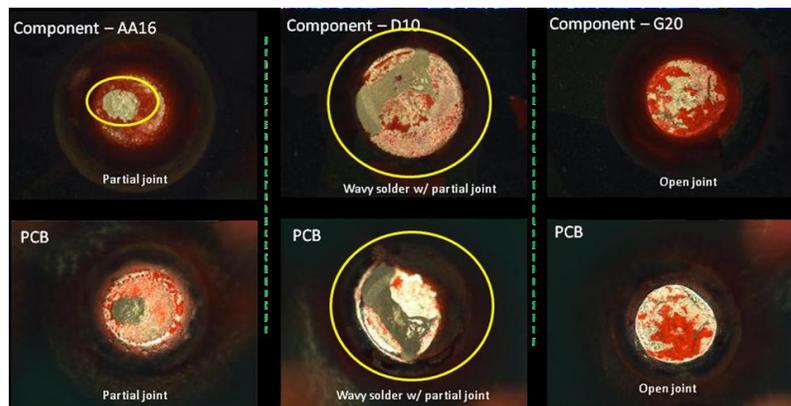
Additional optical and SEM micrographs of failed solder joints at the component side are shown in Figures 4 and 5. These failures initially were diagnosed as ball de-wet or ball drop, pointing to the assembly process as the root cause.

Figure 4: Optical photomicrographs of various fracture surfaces after DnP testing.

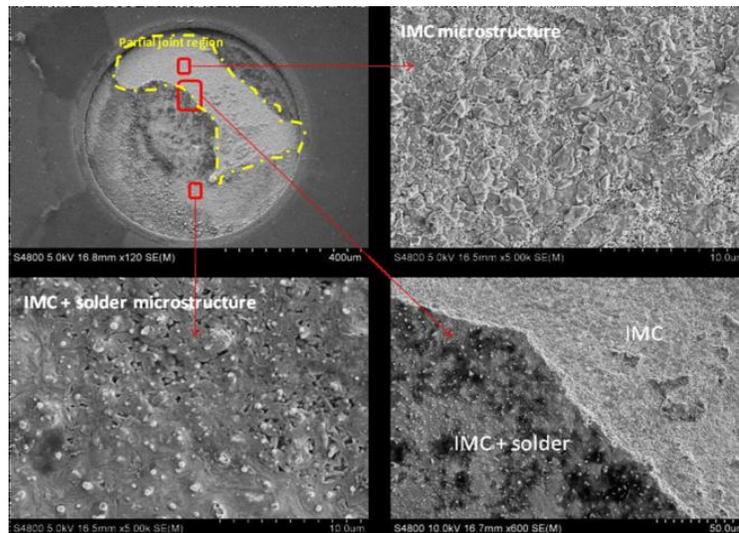
Figure 5: SEM micrographs of various fracture surfaces after DnP testing.

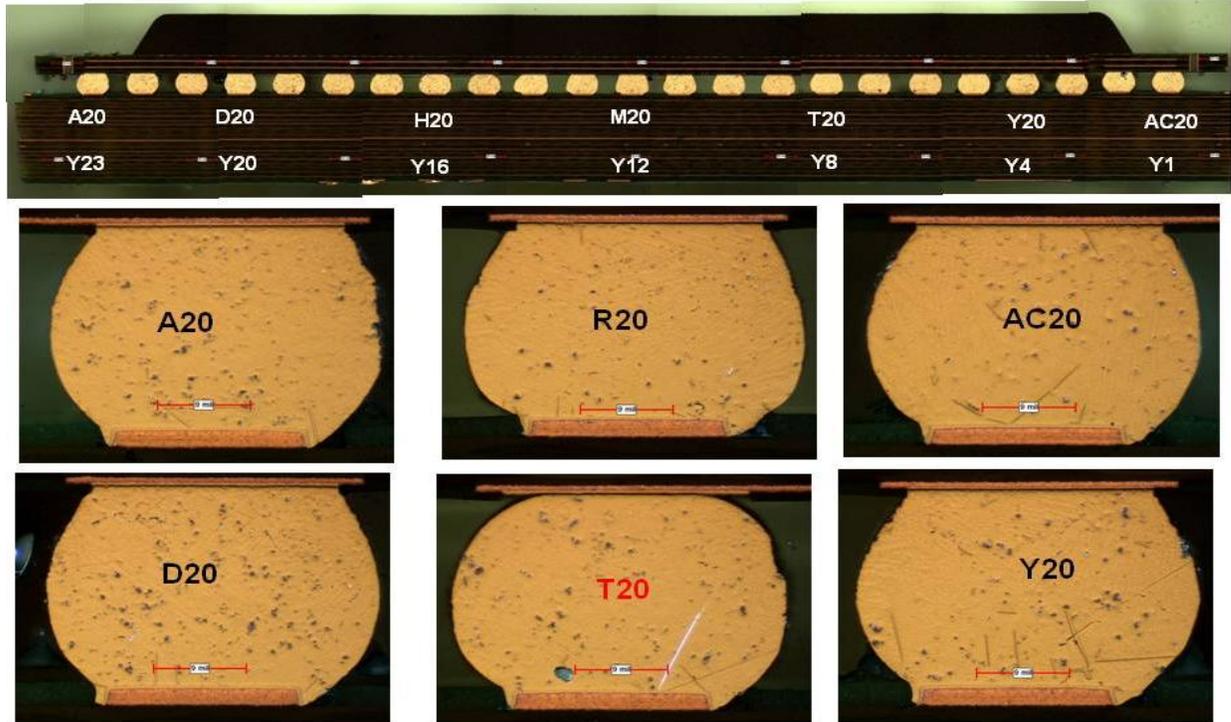
Destructive cross sectional metallographic analysis was performed to provide more detailed and conclusive failure mode data. The analysis was conducted on Component A from a PCBA sample that contained suspected solder joint opens. The component was cross-sectioned with row by row analysis and optical photomicrographs were obtained for multiple solder balls in each row. The photomicrographs in Figure 6 show cross sections of multiple solder balls across Row 20 in Component A. Row 20 is one of the inner rows of the “picture frame” of the BGA package pin diagram. The solder joint at pin location T20 does not appear to be formed properly and this is confirmed in the higher magnification image in Figure 7.

Figure 6: Multiple metallographic cross sections of solder balls in Row 20 of Component A.

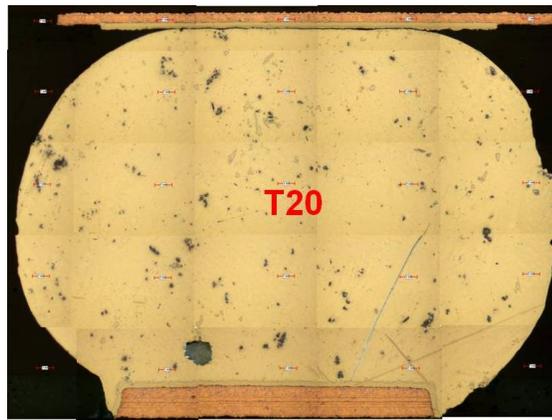
Figure 7: A higher magnification photomicrograph (initial magnification 500X) showing a defect that appears to be de-wetting at package location T20 in Component A. The ball seems to be detached from the package pad.

The initial indication from the high magnification photomicrograph in Figure 7 is that the T20 ball was never soldered to the BGA pad. At this low magnification, the solder ball appears to be de-wetted from the pad. However, an even higher magnification photomicrograph presented in Figure 8 shows that the T20 solder joint actually separated from the BGA pad at the interface between the Ni-Sn (nickel-tin) intermetallic compound (IMC) and the bulk solder. The presence of an IMC layer and a relatively small amount of solder on the PBGA pad confirm the solder ball had been previously attached to the pad. The spherical curved surface of the bulk solder at the perimeter of the solder ball also indicates melting. By all indications, the soldering reaction was successful initially and the solder joint was formed properly. In contrast, the top of the solder ball is flat and parallel to the component pad indicating that a brittle solder joint fracture occurred. This failure signature is consistent with that reported in the Double Reflow references [1, 2] and it is suggested that a similar failure mechanism can account for the T20 solder joint failure. As the solder joint temperature increased and approached the melting temperature during the second reflow, mechanical stress in the PCBA structure was sufficient to induce a brittle fracture at the IMC interface just prior to reaching the melting temperature. The source of the stress could be a combination of CTE mismatch in the package as well as PCB and component warpage. The subsequent melting of the solder ball moments later in the reflow process accounts for curved surface of the solder ball and de-wetted appearance at lower magnification.

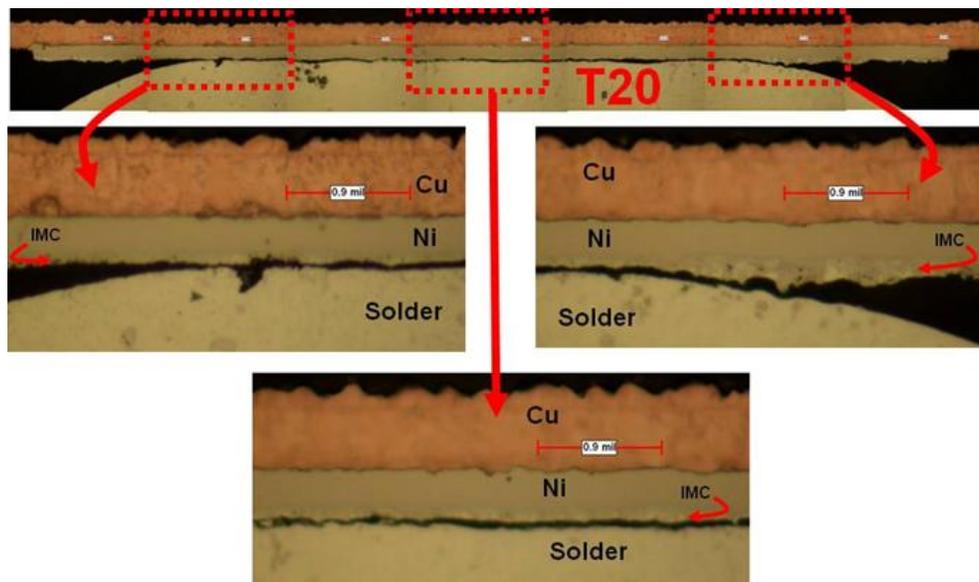
Figure 8: Higher magnification photomicrographs (initial magnification 1000X) adjacent to the T20 BGA pad area showing evidence of a prior successful soldering reaction on the BGA pad with subsequent fracture at the interface between the IMC layer and the bulk solder.

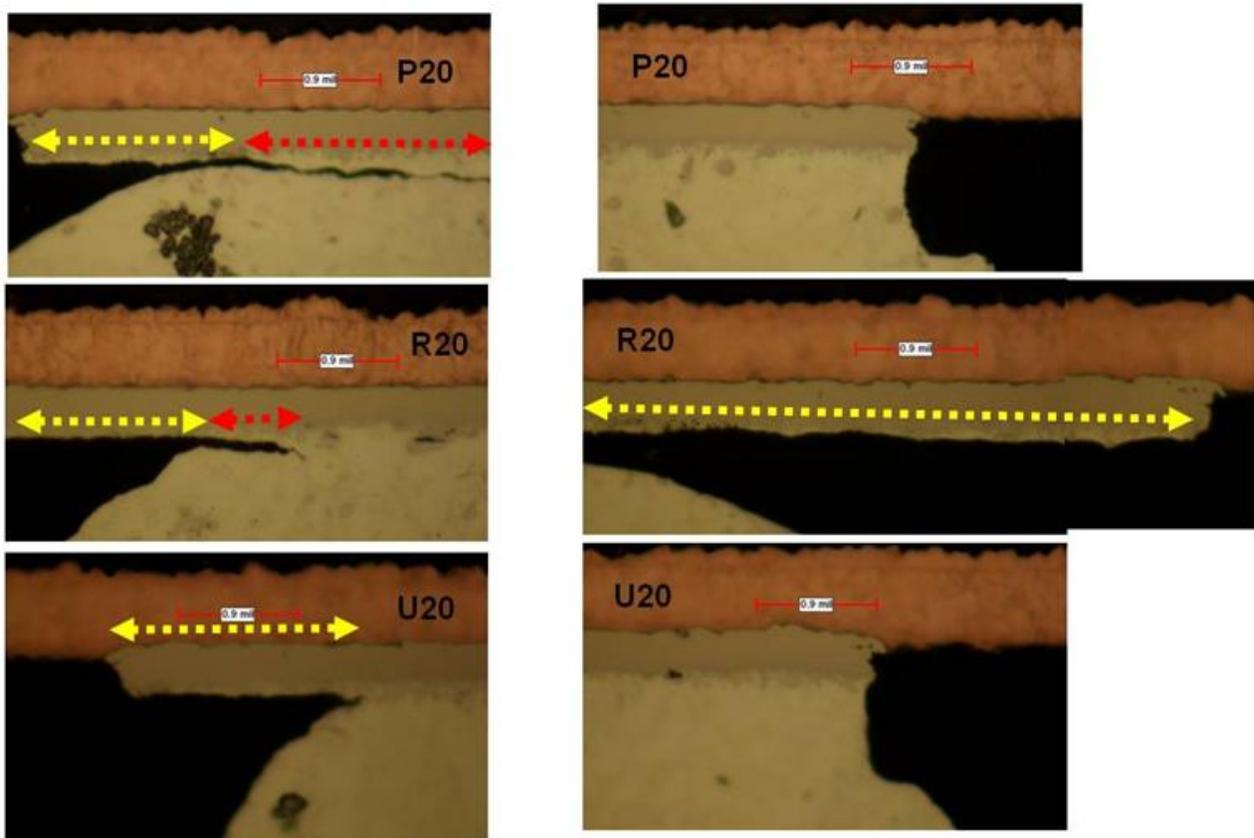
To draw a distinction between the de-wet and brittle fracture modes, the solder joint separation surfaces (interfaces) must be analyzed carefully. In addition to the total separation shown in the T20 solder joint, the three adjacent balls P20, R20 and U20 shown in Figure 9 exhibit similar but partial separation of the solder ball from the Ni-Sn IMC. At first glance, the separations marked by the dashed yellow lines in Figure 9 look like the solder joint de-wetting failures. However the separated areas marked by the dashed red lines in Figure 9, show clear indications of cracking or fracturing rather than de-wetting.

Figure 9 - Magnified cross section, 1000X, of PCBA, Component A, solder balls P-20, R-20, and U-20.

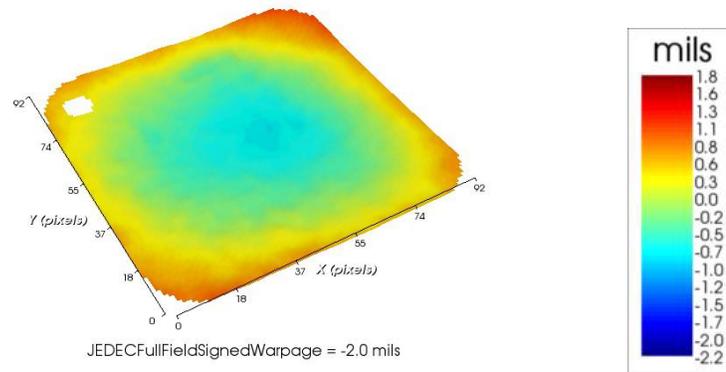
Figure 10: A warpage displacement map across the overmolded area of Component A measured during temperature ramp up at 220°C.

The thermal shadow Moiré data in Table 2 indicate a net displacement or warpage of Component A relative to the PCB of approximately 4 mils during heating in advance of melting or during cooling before solidification takes place (shaded Max. Δ cells in Table 2). It must be acknowledged that there are uncertainties in interpreting these displacement measurements. First, these measurements may not reflect the component and PCBA behavior accurately as it would occur during an actual factory reflow cycle. More importantly, the amount of warpage needed to induce solder joint fracture is unknown. A similar amount of warpage can create other serious BGA defects such as head on pillow (HoP) but HoP is a completely different failure mode [6, 7].

In most applications 4 mils of warpage would be considered acceptable because defects like HoP and dropped ball would not occur. On the other hand, solder assembly defects due to warpage can appear with deviations in warpage as small as a few mils [8]. In the case of BGA double reflow, the magnitude of the warpage and induced thermal stress may not be the primary consideration. The more important factor may be the strength of the solder interconnection at higher temperatures close to the melting and solidification points of the solder. Consequently, it is conceivable that a small stress applied to the solder joint at high temperature when the joint has its lowest strength could cause a brittle interfacial fracture.

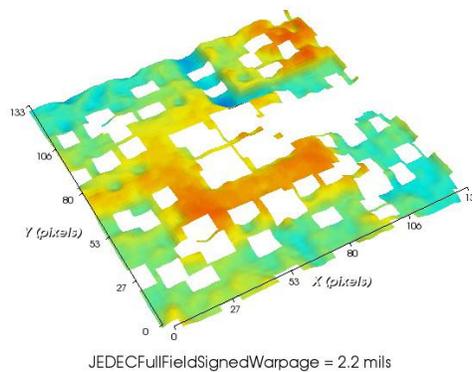
Figure 11: A warpage displacement map for the PCB footprint matching Component A. The measurements were made during temperature ramp up at 220°C.
